Contract #: 04-0120F4Cty: SF/ALA Rte: 80 PM: 13.2/13.9File #: 69.28**WELDING INSPECTION REPORT****Resident Engineer:**Siegenthaler, Peter**Address:** 333 Burma Road**City:** Oakland, CA 94607**Report No:** WIR-019382**Date Inspected:** 19-Jan-2011**Project Name:** SAS Superstructure**OSM Arrival Time:** 700**Prime Contractor:** American Bridge/Fluor Enterprises, a JV**OSM Departure Time:** 1900**Contractor:** Zhenhua Port Machinery Company, Ltd (ZPMC), Changxing Island **Location:** Shanghai, China**CWI Name:** An Qing Xiang, Qiu Wen**CWI Present:** Yes No**Inspected CWI report:** Yes No N/A**Rod Oven in Use:** Yes No N/A**Electrode to specification:** Yes No N/A**Weld Procedures Followed:** Yes No N/A**Qualified Welders:** Yes No N/A**Verified Joint Fit-up:** Yes No N/A**Approved Drawings:** Yes No N/A**Approved WPS:** Yes No N/A**Delayed / Cancelled:** Yes No N/A**Bridge No:** 34-0006**Component:** OBG**Summary of Items Observed:**

BAY 14, OBG 14W (NWIT # 08220)

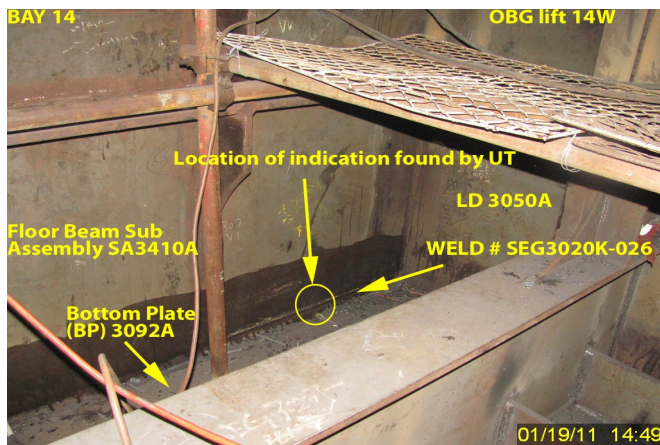
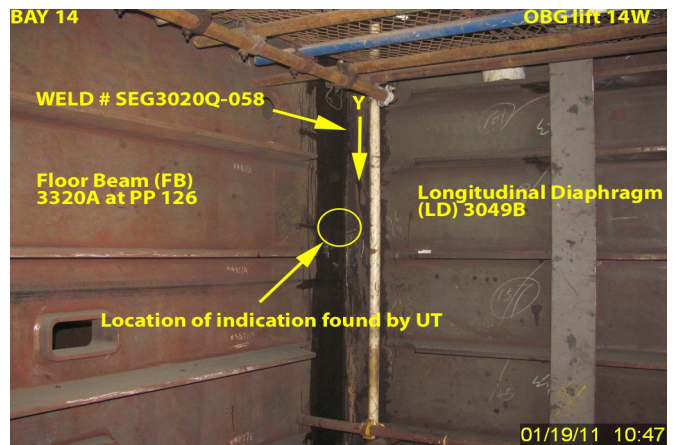
During the Quality Assurance Ultrasonic Testing (UT) verification of welds located on OBG lift 14 West, this Quality Assurance (QA) Inspector discovered the following issues:

-One class "A" longitudinal indication measuring approximately 20mm in length.

-The depth of the indication is 21mm from face A.

- The db rating is +4.
- The material thickness is 30mm.
- The weld is identified as: SEG3020Q-058.
- The Weld is a Complete Joint Penetration (CJP), Tee-joint, joining the Floor Beam (FB) 3320A to the Longitudinal Diaphragm (LD) 3049A at Panel point (PP) 126.
- The “Y” location of the indication is 1575mm from the top end of the weld as shown in the attached photograph.
- The indication is clearly marked on the component.
- The material is identified as Seismic Performance Critical Member (SPCM) and the weld is identified as Fracture Critical Weld (FCW).
- The member is located in Bay 14.

- One class “A” longitudinal indication measuring approximately 20mm in length.
- The depth of the indication is 23mm from face A.
- The db rating is +6.
- The material thickness is 25mm.
- The weld is identified as: SEG3020K-026.
- The Weld is a Complete Joint Penetration (CJP), Tee-joint, joining the Floor Beam Sub Assembly SA3410A to the Bottom Plate (BP) 3092A at Panel point (PP) 127.3.
- The “Y” location of the indication is 450mm from the Longitudinal Diaphragm (LD) 3050A as shown in the attached photograph.
- The indication is clearly marked on the component.
- The material is identified as Seismic Performance Critical Member (SPCM) and the weld is identified as Fracture Critical Weld (FCW).
- The member is located in Bay 14.

The Notice of Witness Inspection Number (NWIT) is 08220. The indication is located inside the area that has been previously tested and accepted by ZPMC Quality Control (QC) personnel. As per the contract documents, ZPMC’s QC personnel are required to perform 100% UT inspection of these welds. Attached photographs provide additional location details.
